Field Report for Airborne Data Collected In Support of US EPA Region VI South 4 Group Fire 27 November 2019

On 27 November 2019 an explosion and subsequent fire was reported at the TPC Group facility located near Port Neches, TX. Local information indicated that at approximately 0100 (central) a large explosion rocked the area. The explosion subsequently caused a massive fire at the facility in a short amount of time. Local official ordered a 4-mile evacuation order which as of 0800 on 27 November 2019 was still in effect. Reported onsite products include various olefins, butadiene, and isobutylene. The geographical coordinates of the facility are 29.9222N, 95.0547W (figure 1).

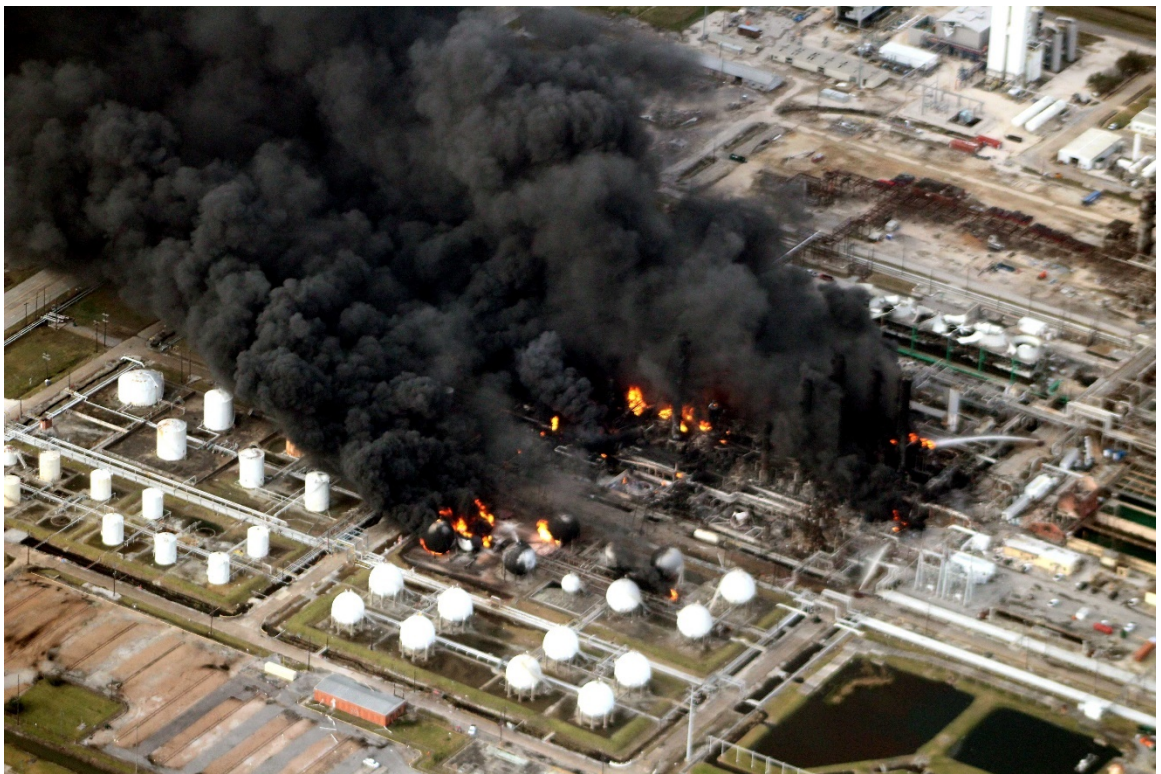
Figure 5: Oblique Image of the TCP Group Fire

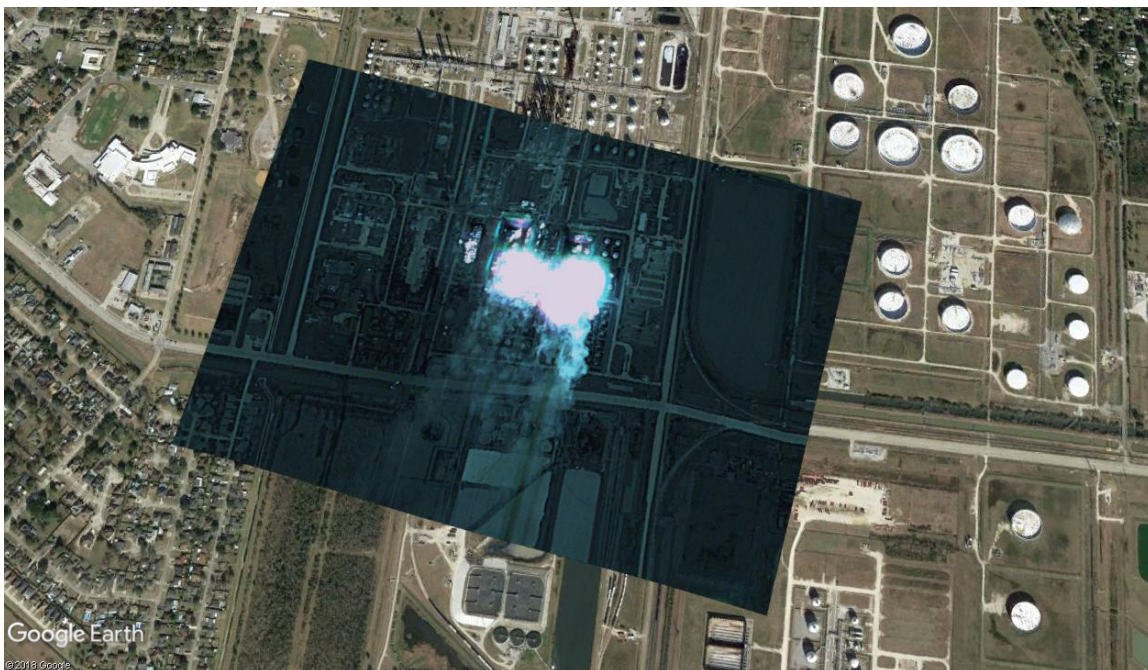
A total of 4 test and 3 data passes were made in the proximity of the fire and an infrared line scanner image was generated for each pass. Analysis of IR imagery generally shows consistency from early flights namely very intense heat within the field of view (figure 11).

Figure 11: – 3 band IR image, TPC Group fire, Flight 3, Run 6
